## **XBOX 360 – Three Red Lights of Death Repair Manual**

What the modification contained in this manual achieves is to alleviate board flexing and apply uniform pressure to the processors. This uniform pressure is enough to 'remake' the faulty joints resulting in a working console. Also, because the pressure on the processors is uniform the heat sinks do a much better job of dissipating the heat build up.

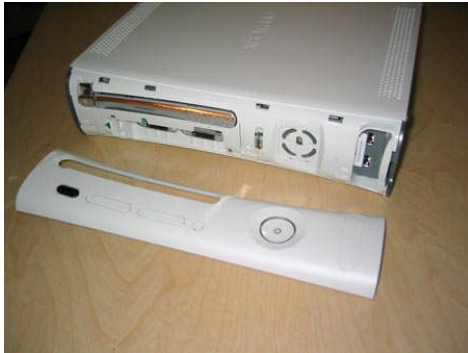
Firstly, remove the front face plate from your Xbox: Take a look at the front of the Xbox 360 and insert your thumb into the door that covers the two USB ports on the right of the unit. With your other hand squeezing the upper and lower sides of the face plate, pull out the face plate with your thumb. With not much effort, the face plate should come away from the unit with ease. I wouldn't force it however –if it doesn't want to come off easily it will be catching on something. You don't want a trashed console case after all your efforts.

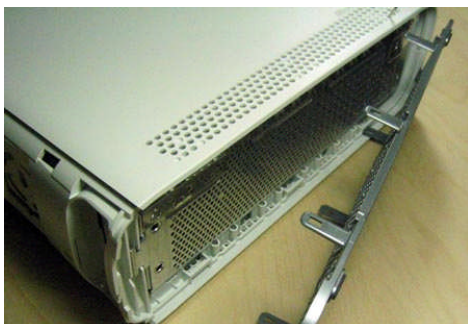
With care, gently bend outwards, the right grey ventilation shield on the right side of the unit so that you can see a bit inside. You will notice that the grey side piece attaches to both the bottom and top white chassis. Look through the holes on top of the unit to locate the areas where the grey side pieces attach to the white housing. What you need to do is take the thin skewer and push down, through the white holes (located on both the top and bottom of the Xbox 360) where the clips of the grey side pieces connect. Slowly pull out the grey pieces away from the unit while unlocking the clips and eventually it will release itself. You will find that once the first couple of clips are released the rest come away quite easily. You don't have to use a wooden skewer for this. If you have a metal rod (or the inside of a BIC type pen) this will work too.

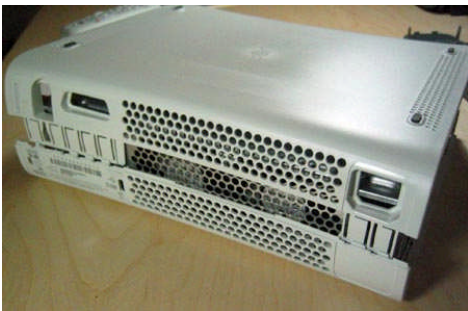
1. There are 6 retention slots on the rear of the unit and 4 clips on the front of the unit
2. Unlatch the four front clips first using the terminal driver.
3. Once all 4 are undone, gently lift up the front of the case about an inch
4. Locate the six slots on the rear of the unit
5. Using the terminal driver, push gently but firmly inwards on each slot in turn
6. If done successfully, you will hear a click each time.
7. Once all 6 are unclicked, we can lever up the rear of the case and remove this half completely.

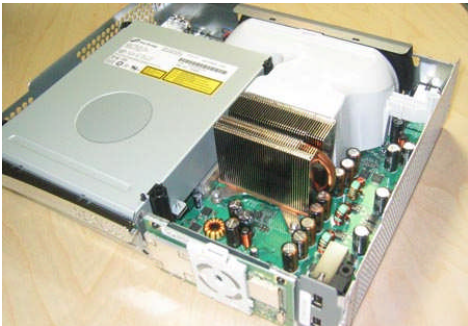
8. Flip the unit over and you will see 14 silver screws and 8 black screws. Remove these using the T10 Torx driver and the T8 Torx driver respectively.
9. Once all the screws are removed, turn the Xbox over and you can lift off the top part of the case.

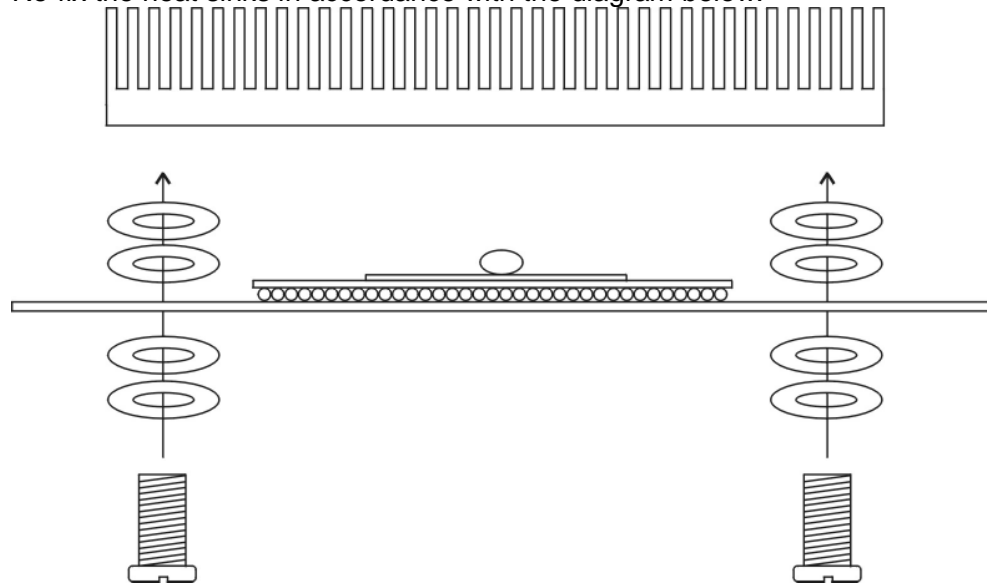
9. Re-fix the heat sinks in accordance with the diagram below.

10. When tightening the screws, do top left, then bottom right, then top right followed by bottom left. At this stage do not over tighten the screws. Just use a finger and thumb on the screwdriver and stop when you can't easily turn it further.
11. Once all four screws on each heat sink are done up as per step 9, tighten each screw one more quarter turn.

1. When reaffixing the heat sinks, only use one washer on the underside of the motherboard. This forces the clamps down harder onto the processors. This can also be achieved by using a shim or similar between the heat sink and processor.
