XBOX 360 – Three Red Lights of Death Repair Manual

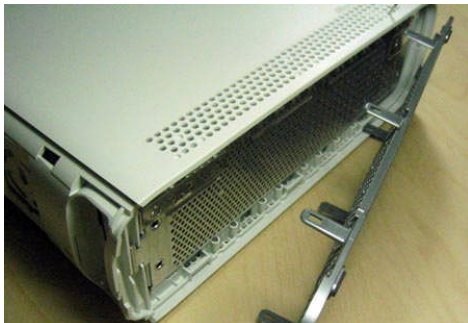
With care, gently bend outwards, the right grey ventilation shield on the right side of the unit so that you can see a bit inside. You will notice that the grey side piece attaches to both the bottom and top white chassis. Look through the holes on top of the unit to locate the areas where the grey side pieces attach to the white housing. What you need to do is take the thin skewer and push down, through the white holes (located on both the top and bottom of the Xbox 360) where the clips of the grey side pieces connect. Slowly pull out the grey pieces away from the unit while unlocking the clips and eventually it will release itself. You will find that once the first couple of clips are released the rest come away quite easily. You don't have to use a wooden skewer for this. If you have a metal rod (or the inside of a BIC type pen) this will work too.
